PG: Inventory No. 82A-56

## Maryland Historical Trust Maryland Inventory of Historic Properties Form

1. Name of F	Property	(indicate preferred	name)			
historic						
other	Tayman Tobacco	Barn at Sasscers Green				
2. Location						
street and number	8008 Croom Roa	nd				not for publication
city, town	Upper Marlboro					vicinity
county	Prince George's

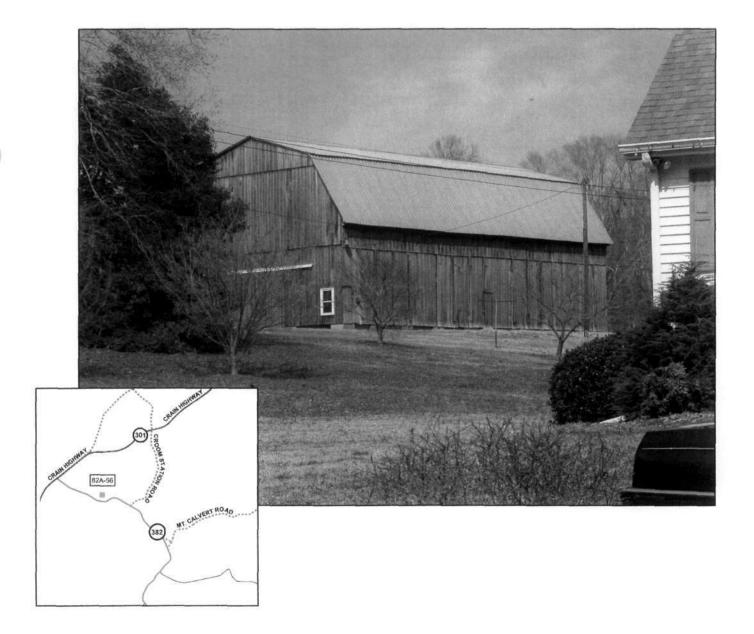
Sited to the west of Croom Road near dwellings and a school, this barn is sited in a field near mature trees. This c.1945 barn has a concrete block pier foundation supporting a wood frame structural system clad in vertical boards and a gambrel roof covered with standing seam metal. Hinged air doors line the north and south elevations. Sliding vertical board doors are positioned in the east and west elevations. The west elevation also has a 1/1-light vinyl sash window.
